## Air Barrier Solutions for Knee Walls Exposed to Attic Conditions

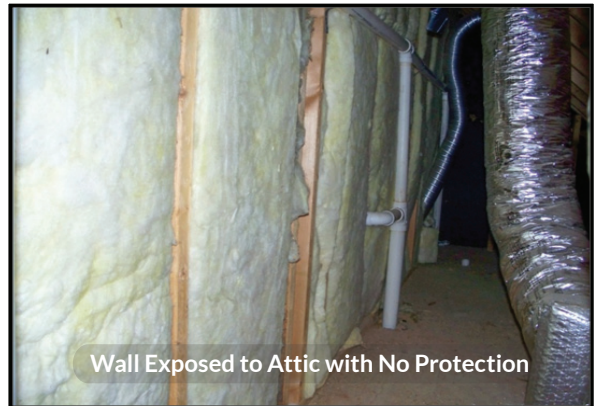
Wall Exposed to Attic with No Protection

- Attic temperatures climb to extreme levels in the summer, creating an oven on the other side of your wall.
- Winter attic temperatures are significantly lower than room temperatures and cause rapid heat loss.
- Exposed fiberglass batts often pull away from wall boards dramatically reducing R-value performance.
- Air movement around the surface of exposed fiberglass batt reduces R-value.
- HVAC load often reaches peak performance and cannot maintain comfortable building temperatures.

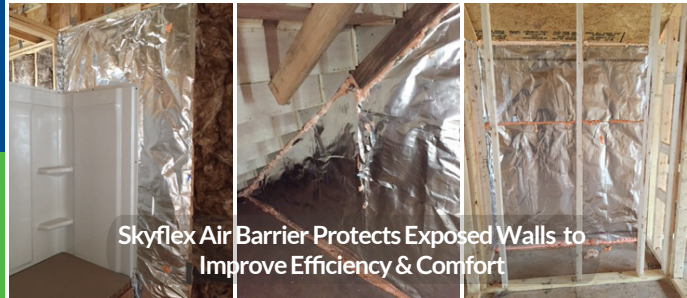
Skyflex Air Barrier Protects Exposed Walls to Improve Efficiency & Comfort

Install Fi-Foil Air Barriers over the face of wall studs exposed to extreme conditions

- Reflect heat away from surface of insulation reducing radiant heat gain in the summer
- Reduce radiant heat loss in the winter
- Secure fiberglass batt against wall board
- Increase R-value and performance when used with other insulation such as batt, gypsum or spray foam
